RE: Thompson residence septic system service and inspection

Septic System Inspection Checklist Report

Address: 42 Holiday Hills Blvd, Howard, CO 81233

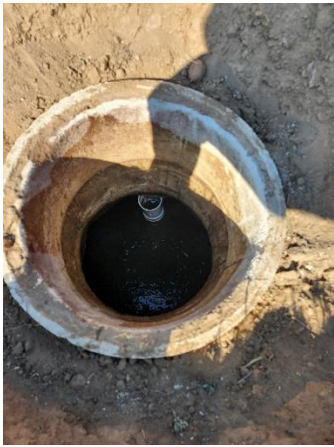
Influent baffle, south chamber

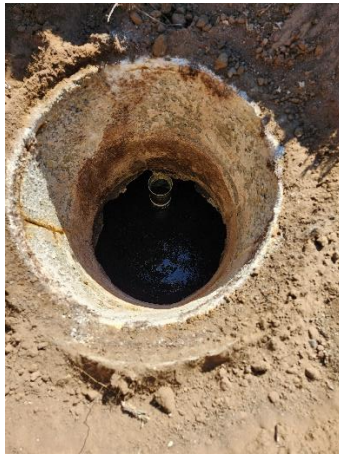
Effluent baffle, north chamber

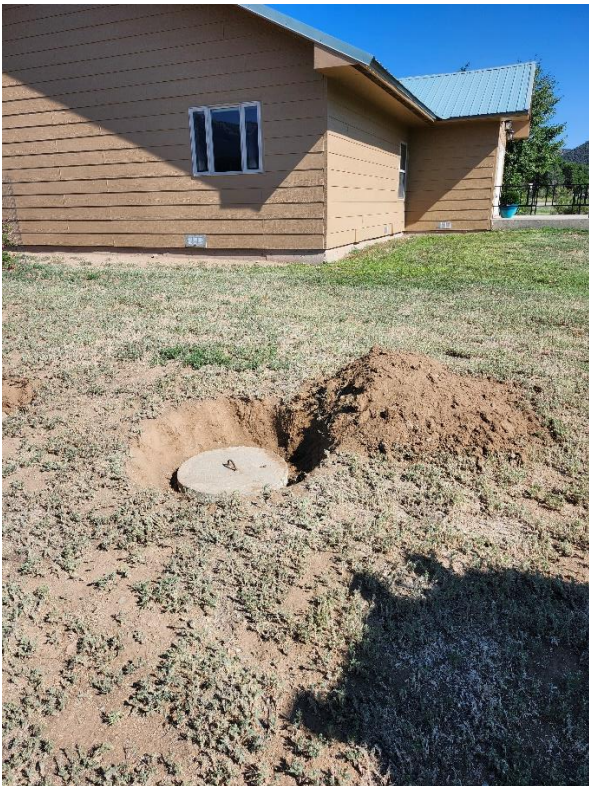
View of north chamber lid 25' from home

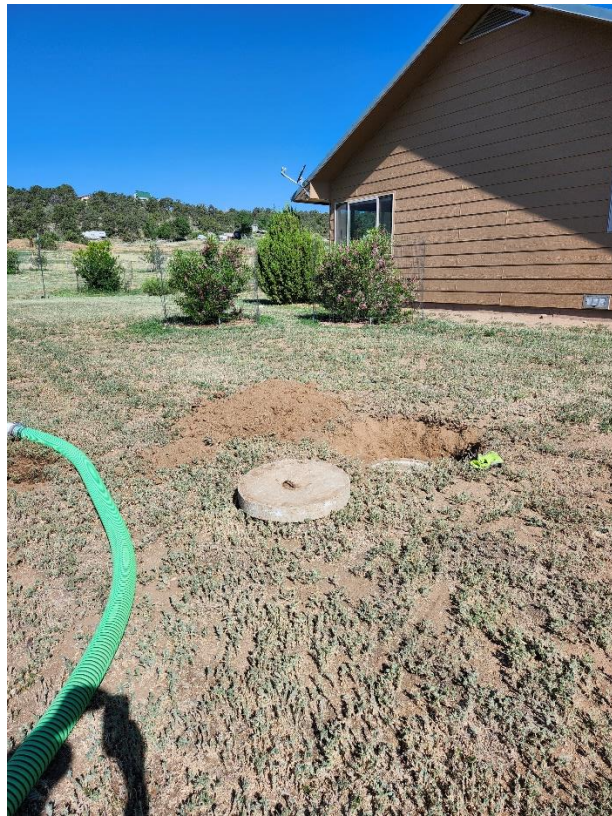
View of south chamber riser looking towards the SE corner of the home. The sewer line runs from the SE corner of the home to this south chamber of the septic tank.
